Parking Structure Damage

Investigation and repair restores structure to service

BY SCOTT M. ADAN AND RENÉ W. LUFT

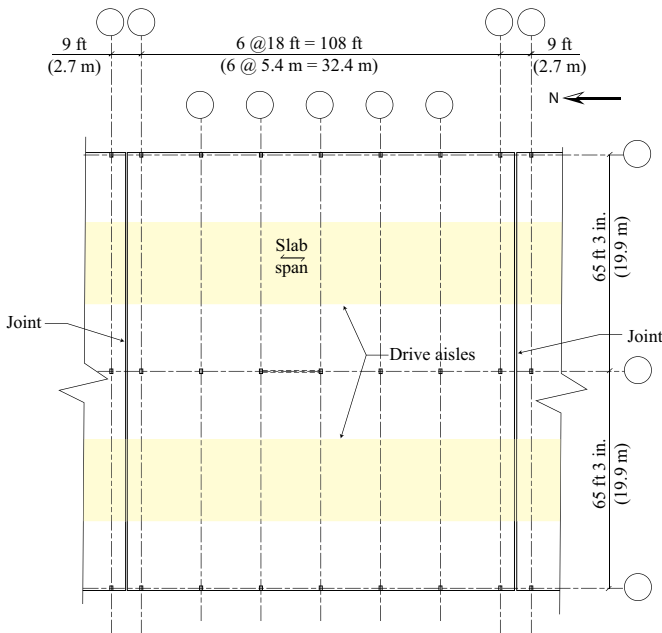
Fig. 1: Schematic plan of deck bays between expansion joints. Post-tensioning strand anchorage strips are located near the joints. Transverse post-tensioned beams are at the east-west grid lines

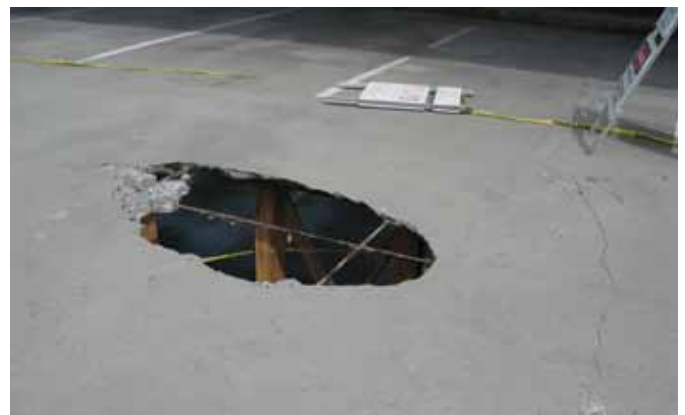
4 x 5 ft (1.2 x 1.5 m) hole in the slab (Fig. 2), but the failure did not rupture the tendon strands.

Fig. 2: Cracked and partially collapsed concrete slab showing exposed post-tensioning strands

Several months after the damage occurred and while repairs were underway, a witness came forward and reported that a loaded concrete truck had accessed the upper level of the structure (prior to the repair, the garage had no vehicle height barriers to prevent such an occurrence). Reportedly, the truck circumnavigated a large portion of the deck, explaining why the damage was primarily concentrated in the drive aisles. The axle load imposed by such trucks typically would be much higher than the code-prescribed loads and can (as in this case) cause serious damage.
