# Parking Structure Damage

Investigation and repair restores structure to service

BY SCOTT M. ADAN AND RENÉ W. LUFT

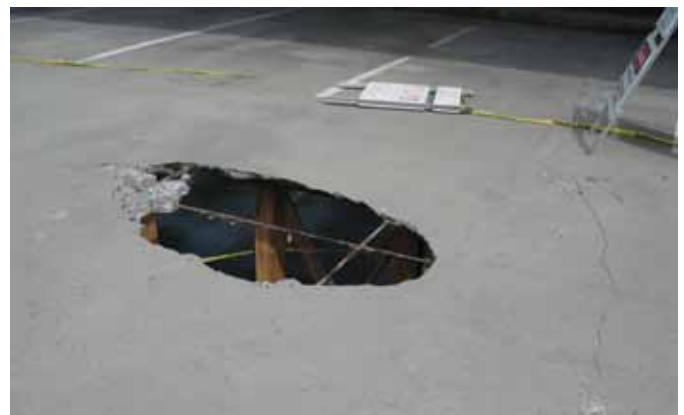
4 x 5 ft (1.2 x 1.5 m) hole in the slab (Fig. 2), but the failure did not rupture the tendon strands.

Surrounding the hole and at numerous other locations, we found severe slab cracking and deflection. Due to the extent of damage, the local building department “red-tagged” the structure and the entire garage was subsequently taken out of service. We also recommended that the owner have shoring installed around the hole.

Fig. 2: Cracked and partially collapsed concrete slab showing exposed post-tensioning strands

Several months after the damage occurred and while repairs were underway, a witness came forward and reported that a loaded concrete truck had accessed the upper level of the structure (prior to the repair, the garage had no vehicle height barriers to prevent such an occurrence). Reportedly, the truck circumnavigated a large portion of the deck, explaining why the damage was primarily concentrated in the drive aisles. The axle load imposed by such trucks typically would be much higher than the code-prescribed loads and can (as in this case) cause serious damage.

in the vertical faces of the repair area and reinforcing dowels were anchored with epoxy adhesive (Fig. 9) to tie the new concrete to the existing slab. Also, exposed strands were wrapped with tape to prevent bonding with the new concrete. In less severely damaged areas, cracks were repaired using epoxy injection. To verify tendon integrity and tension, the contractor reseated the existing strands at a higher tension level (Fig. 10). Remarkably, during the reseating process, only one strand was found to be ruptured. The contractor removed and replaced the ruptured strand by welding a new strand to the existing strand and pulling the existing strand at the opposite end.

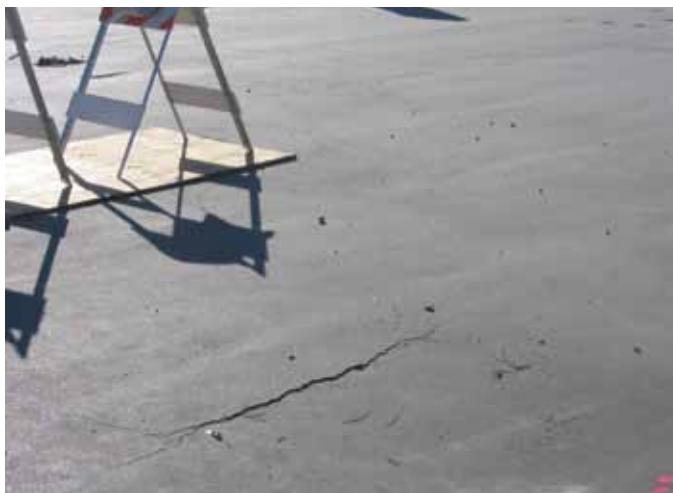
Each of the affected slabs had extensive cracking, both at midspan and near supporting beams (Fig. 3). In many of these spans, we measured maximum slab deflections of about 3 to 4 in. (75 to 100 mm) between beams. There was, however, no indication that post-tensioning tendons had ruptured.

**Fig. 3: Slab cracking at the edge of a supporting transverse beam below**

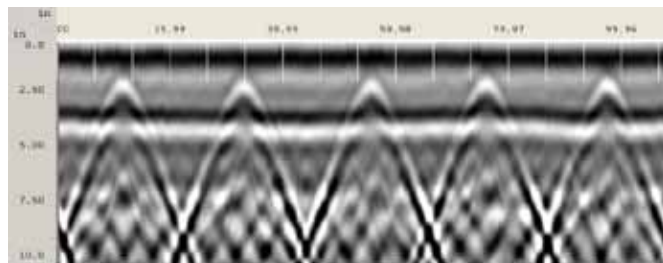
We had no information on post-tensioning reinforcement as the available partial set of construction drawings contained architectural but no structural drawings. To determine the extent and location of the reinforcement, we surveyed the slabs with ground-penetrating radar (GPR) (Fig. 4). Data from the GPR surveys were verified using limited destructive tests, allowing us to determine the size, depth, drape, and spacing of the tendons.

**Fig. 4: Ground penetrating radar (GPR) was used to evaluate slab thickness and reinforcing bar locations**

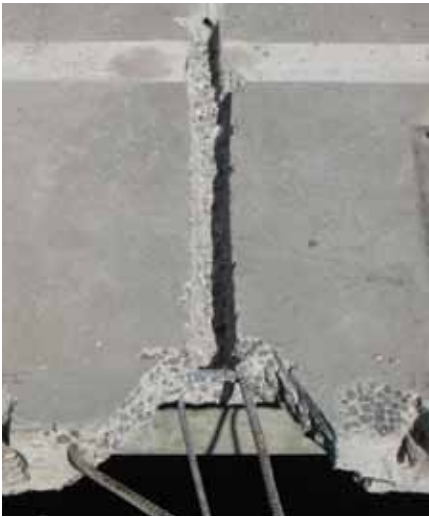
**Fig. 5:** Existing tendon anchors (lower right) were exposed to allow reseating. Here, a slot has also been provided to allow an external tendon to be anchored at middepth of the slab, near the existing tendon anchors

Our design called for the addition of six 1/2 in. (13 mm) diameter post-tensioning strands in an inverted king post truss configuration below each of the affected drive aisle slabs. The strand profile was selected to apply an upward reaction at the slab midspan and transfer the vertical force to the supporting beams at holes traversing their webs near the slab soffit. To avoid eccentricity at anchorage locations, the strand anchors were positioned at middepth of the slab in precut slots (Fig. 5). This also allowed the tendons to be anchored adjacent to the existing anchorages.

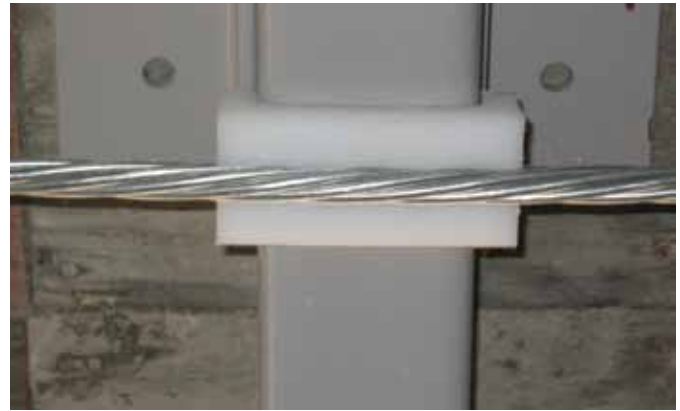
**Fig. 8:** Detailed view of HSS deviator, high-density polyethylene saddle, and galvanized strand

Although external post-tensioning of beams is a well-established technique, external post-tensioning of a thin slab presents challenges. The magnitude of the upward reaction was selected to lift the slab to its original elevation relative to the beams. To avoid a high concentrated load at each strand deflection point, a continuous hollow structural section (HSS) deviator was used (Fig. 6 and 7) to distribute reactions uniformly to the slab. The HSS also simplified construction by reducing the corresponding number of center post attachments. To prevent abrasion on the HSS surface, a prefabricated high-density polyethylene saddle was fitted at each strand intersection (Fig. 8). Each saddle could be field-

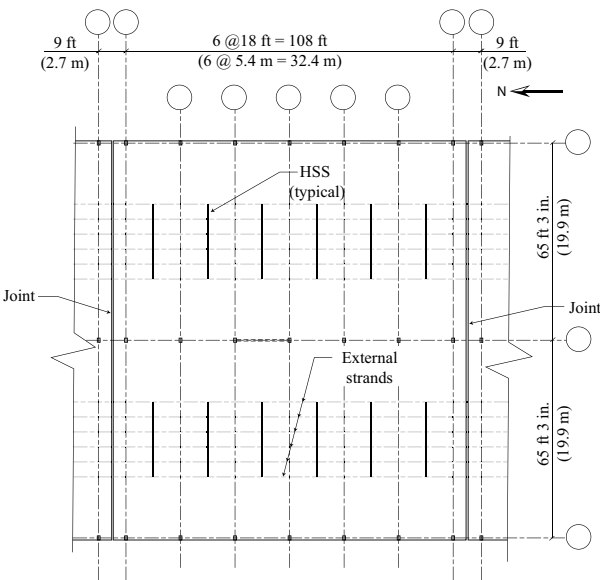
**Fig. 6:** Typical locations of HSS deviators and external post-tensioning strands

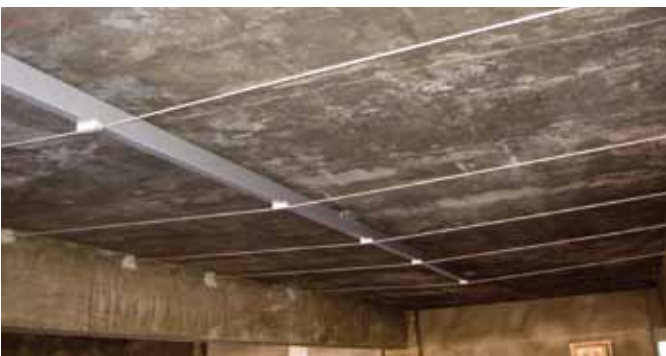
**Fig. 7:** HSS deviators were fastened to the slab soffit at the midspan of the slab. Post-tensioning strand traversed the beam webs near the slab soffit elevations and passed below high-density polyethylene saddles at the HSS

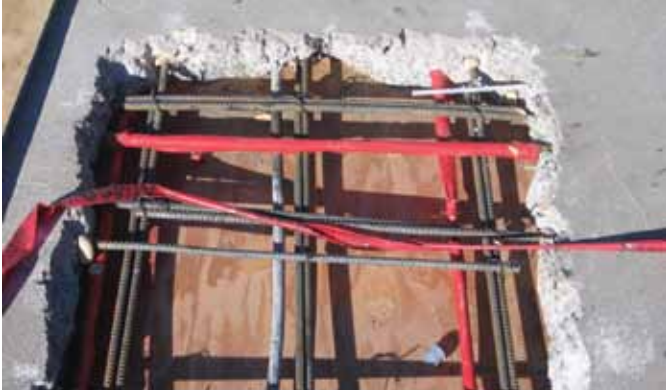
**Fig. 9:** In areas with severe damage, unsound slab concrete was removed and replaced. Here, reinforcing dowels have been anchored into the existing slab and exposed strands have been wrapped to prevent bonding with the new concrete

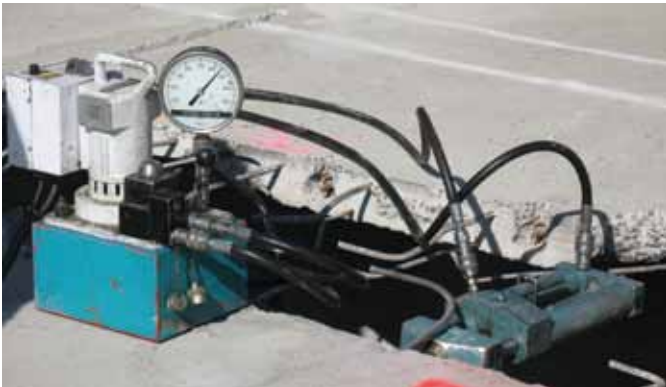
**Fig. 10:** Reseating an existing tendon anchorage. A slot for an external tendon is visible behind the pump
